## Lessons Learned in the Processing of Polycyanurate Resin Composites

15 February 2002

R. J. ZALDIVAR  
Space Materials Laboratory  
Laboratory Operations

SPACE AND MISSILE SYSTEMS CENTER  
AIR FORCE SPACE COMMAND  
2430 E. El Segundo Boulevard  
Los Angeles Air Force Base, CA 90245

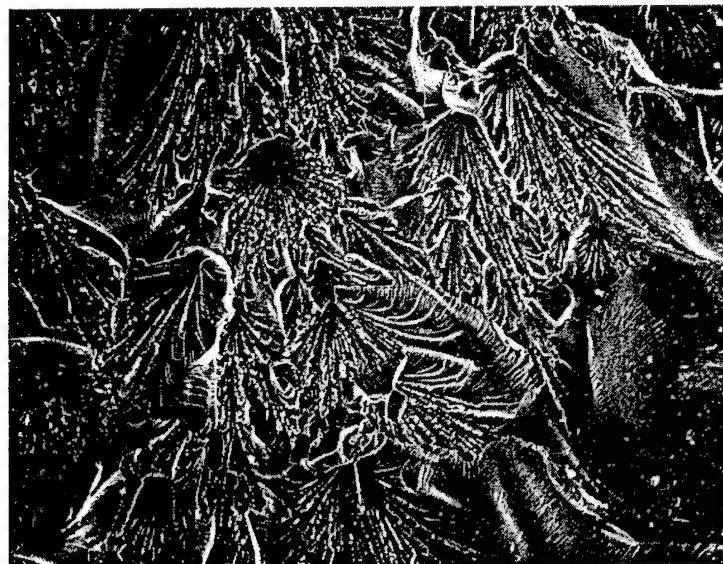
Figure 12. Fracture surface of typical polycyanurate resin dogbone sample. Sample exhibits ductile failure.

properly cured in an inert atmosphere and exhibited no carbamate formation show a ductile failure, as evidenced by the highly yielded and dimpled fracture face shown in Figure 12. The same type of fracture surface is observed for all of the high-strength resin samples. Figure 13 shows the fracture surface of a specimen that has experienced some carbamate formation. This fracture surface indicates a less compliant or yielding failure than that of the previous samples. As verified by the mechanical test data, the strain-to-failure of this sample was considerably lower than the control sample.

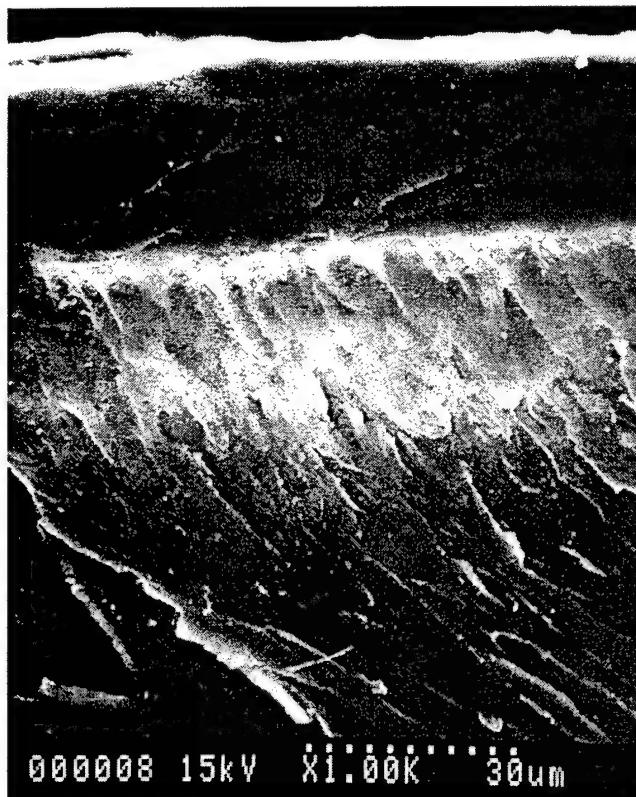
Figure 15. Fracture surface of typical polycyanurate resin dogbone sample that has been pre-exposed to moisture during processing and has carbamate formation as verified by FTIR. Shell-like brittle fracture is formed on outer surface of sample.
